## **REPORT OF TEST RESULTS**

REPORT NO: NAWCADPAX/RTR-2001/17

### **BOEING 767 PROXIMITY EVALUATION WITH F/A-18C AND S-3B AIRCRAFT**

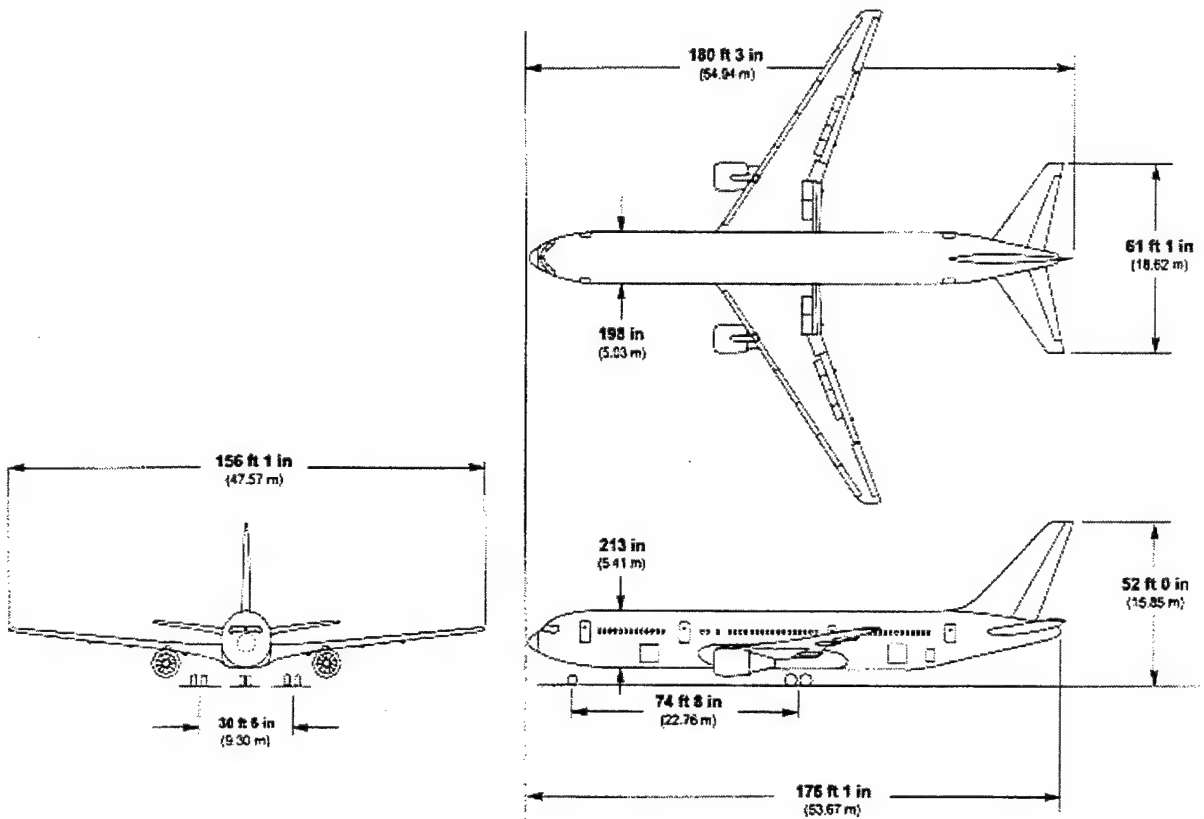
**Boeing 767-300/-300ER**

APPENDIX A  
BOEING 767-300ER AIRCRAFT DIMENSIONS AND TEST MARKINGS

7. Test Aircraft Modifications/Instrumentation. No receiver aircraft modifications or instrumentation was required for this evaluation. To aid in the documentation of aircrew comments however, the F/A-18 aircraft was equipped with a TRIDECK video recording system (120 min HI-8 tape) which was used to record head up display (HUD) video and the S-3B used a hand-held voice recorder. The 767 airplane was marked on the wings and fuselage to assist the receiver aircraft in position keeping. Drawings of the markings on the 767 aircraft are included in appendix A.

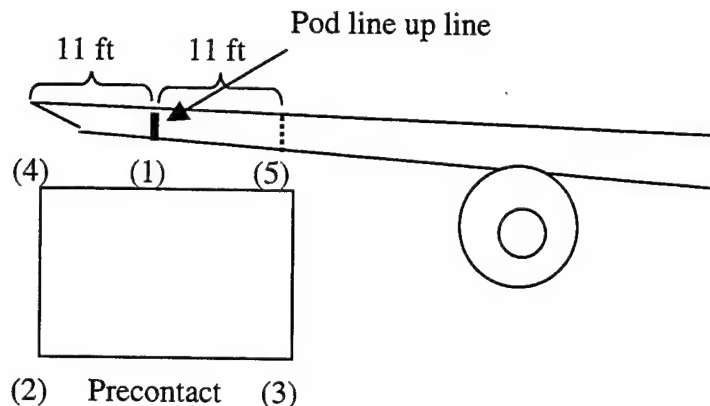
Figure B-1: Wake Box  
(left wingtip shown, right wing is mirror image)

- b. Centerline Precontact Position: Proximity testing for a given airspeed/altitude condition began at the centerline position. From the left or right observation position, the receiver aircraft was cleared into the centerline precontact position (100 ft aft of the rear of the aircraft with 40 ft of step down). Once established, the receiver aircraft performed the box evaluation as described below:

- c. Centerline Fuel Transfer Zone: For testing at the centerline FTZ, the receiver aircraft was positioned 75 ft aft of the rear of the 767 aircraft (on centerline) with 30 ft of step-down. Once established in the FTZ, the receiver aircraft performed the box evaluation as described below:

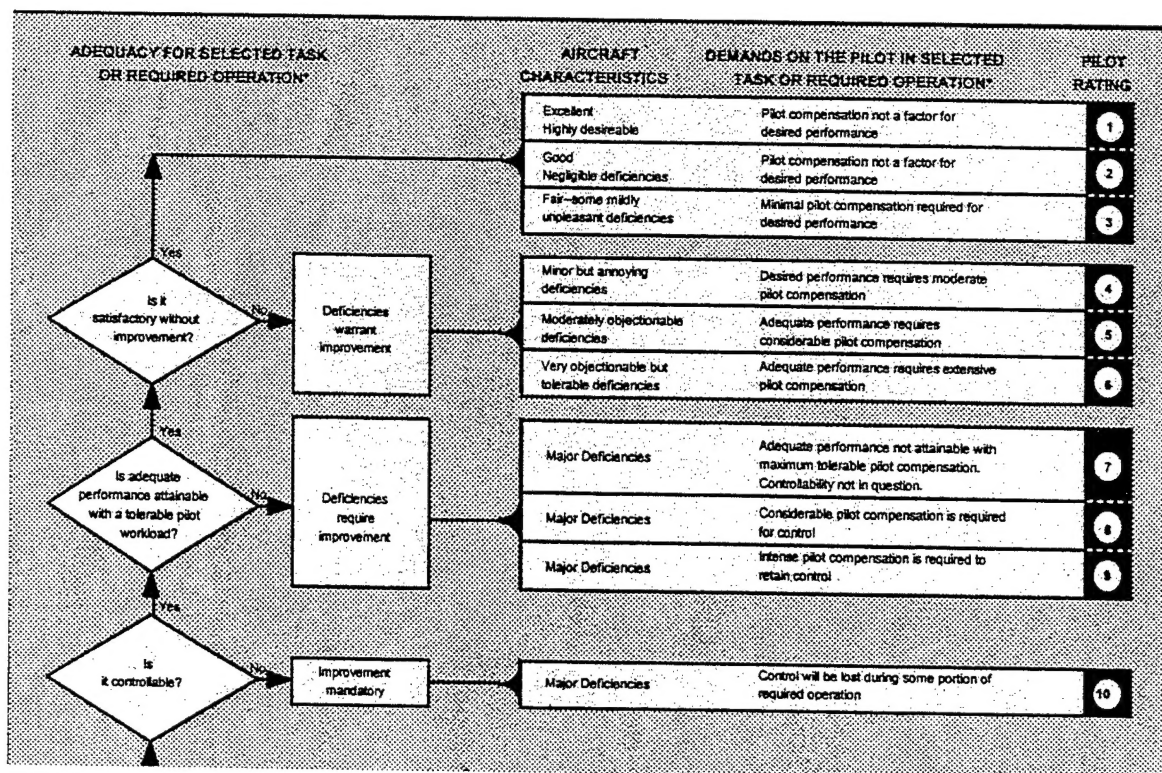
Figure D-1: Cooper-Harper HQR Scale

13. Handling Qualities Ratings (HQR's) were used to rate the performance and workload associated with positioning and maintaining the receiver aircraft in a steady position behind the 767 aircraft. The pilot HQR's were relative to the pilot's own assessment of acceptability. If Pilot Induced Oscillations (PIO's) were encountered, a PIO rating scale was used. The HQR and PIO rating scales are depicted in appendix D. The pilot's task was to maintain a steady aircraft position of  $\pm 5.0$  ft (adequate) or  $\pm 3.0$  ft (desired) at various locations behind the 767 aircraft. Estimated aircraft control input requirements were provided with the HQR's. During all maneuvers in or near the 767 aircraft wake, pilots of the receiver aircraft noted the presence or absence of handling qualities anomalies. Changes in handling qualities while moving from one position to another were also noted. Since in-flight refueling is an inherently work intensive task, HQR's of 3 or better for the F/A-18C and 4 or better for the S-3B were desired. The test point abort criteria was defined with a HQR-7 or when  $\frac{1}{2}$  lateral or directional control displacements were required to maintain positioning or when aircraft trim was saturated in any axis. Light air turbulence or less was considered necessary to conduct an accurate evaluation of the 767 wake turbulence.

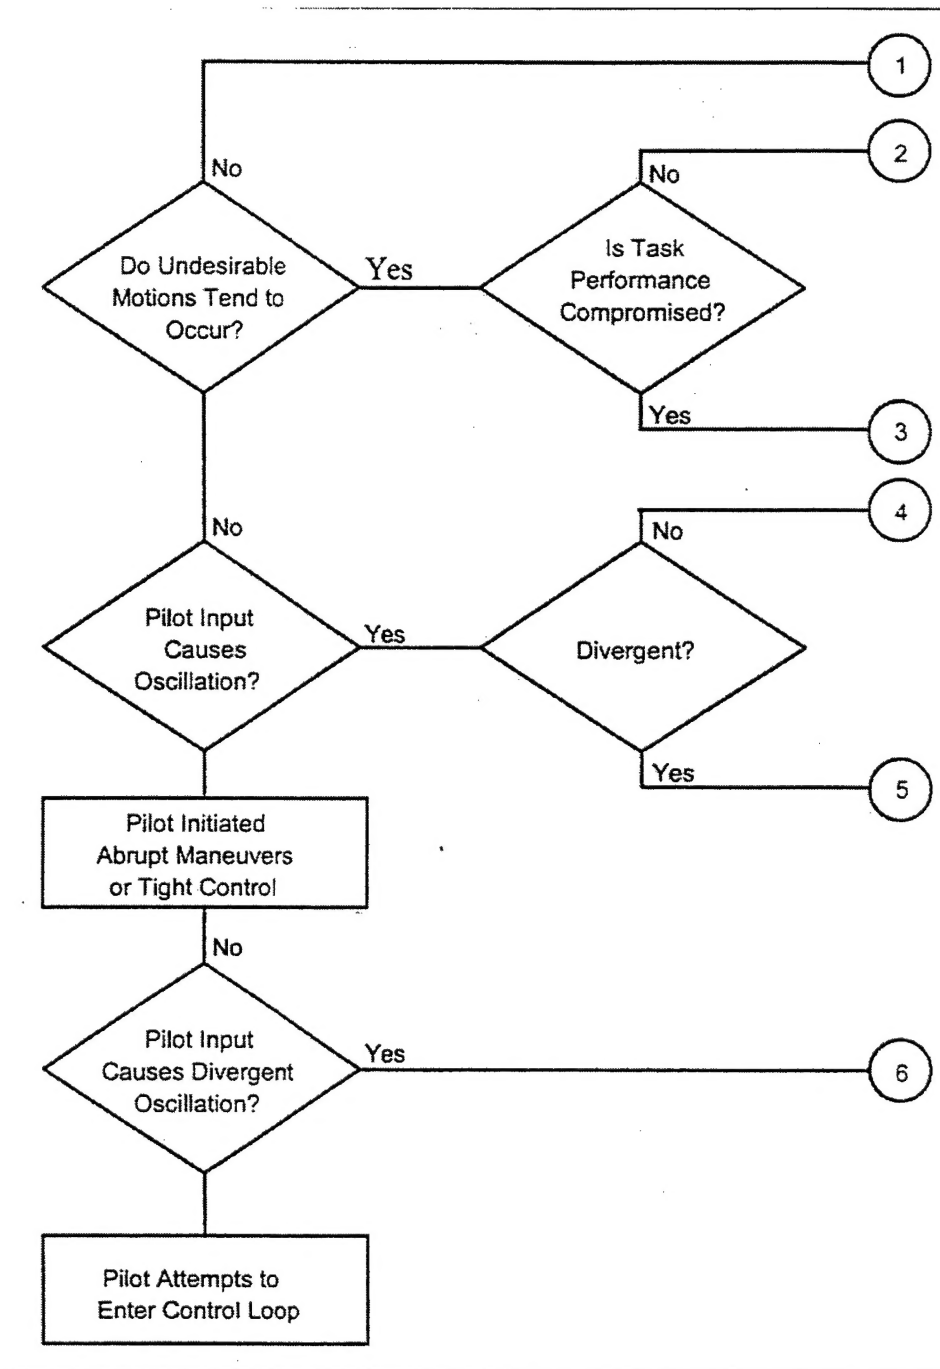
Figure D-2: PIO's Rating Scale
